## KnowRISK

### Know your city, Reduce selSmic risK through nonstructural elements

Deliverable C2 – Identification of the most vulnerable non-structural components in the pilot study areas

Task C - Non-structural seismic risk reduction

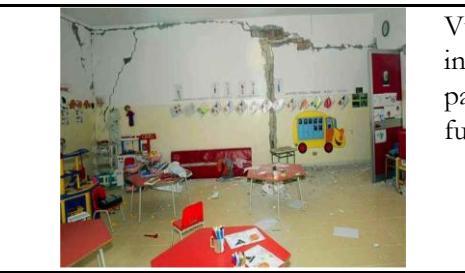
Vulnerable ceiling	Ceiling plasters	Detachment of ceiling plasters
Vulnerable ceiling	Weak anchorage of overloaded ceiling due to lights	Electical system overloading roof plaster slabs
Vulnerable chimney	Weak and loose anchorage	Weak anchorage of tall chimney to the wall; upper slab just laying on top without any anchorage.
Vulnerable ceiling in computer labs	Weak or loose slicee of ceiling moulding	Weak or loose anchorage in computer rooms

Vulnerable interior parition and furnishing

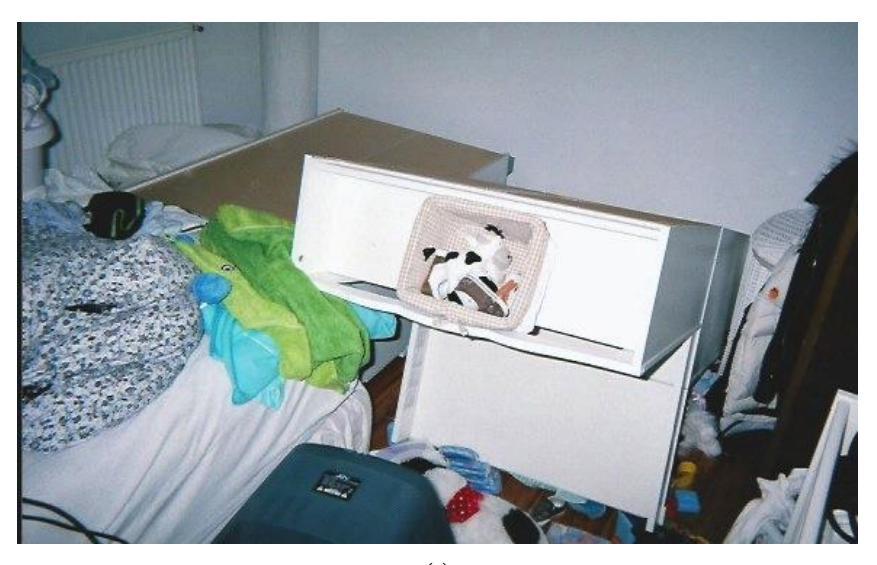
An example of photographic data from the EERC dataset is given in Figure 6. According to Damage State criteria, all photos fall under DS 5, extensive disruption. The photos are from the same building, a SFD in a high-ground motion region, but are from separate rooms in the house. The general opinion of the residents was that most of the damages occurred in the kitchen. An objective of the analysis is to determine if it is possible to determine different levels of disruptions for different rooms in the buildings.

Figure 6. Non-structural elements in the 2000 earthquake, (a) master bedroom, (b) children's bedroom (c) hall (d) kitchen, (e) living room, and (f) washroom

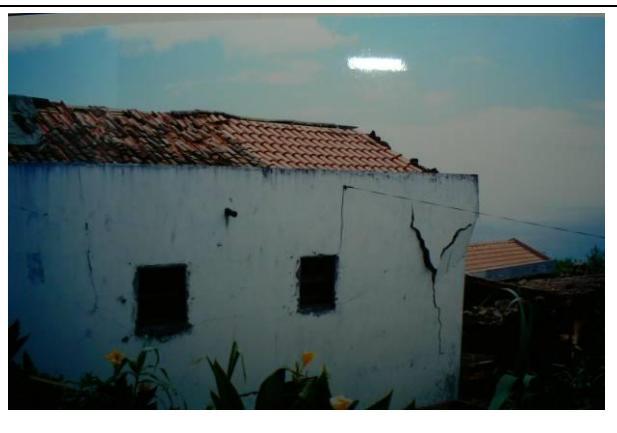
Falling of tiles. Large and extensive cracks in the exterior walls.

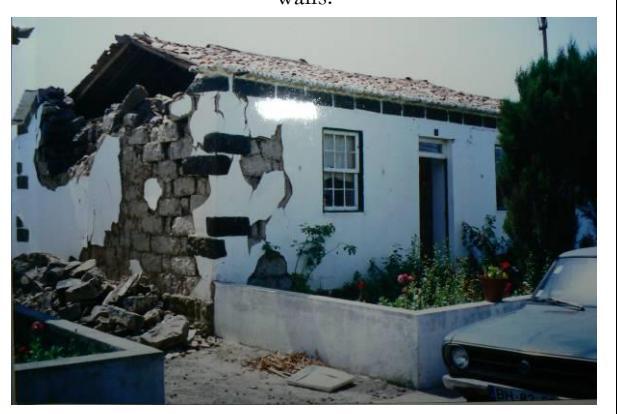
Partial failure of wall.

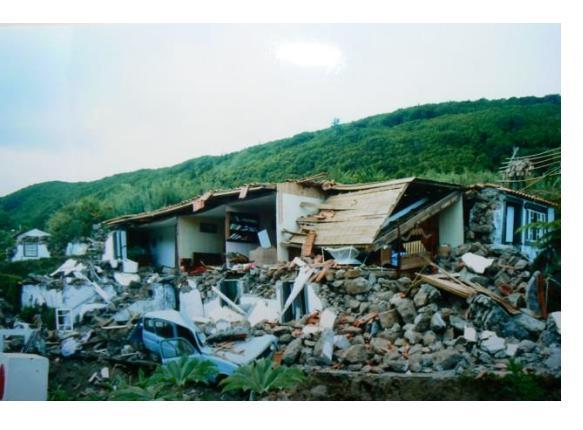
D5

Collapse of masonry walls.
