## KnowRISK

### Know your city, Reduce selSmic risK through nonstructural elements

Deliverable C2 – Identification of the most vulnerable non-structural components in the pilot study areas

Task C - Non-structural seismic risk reduction

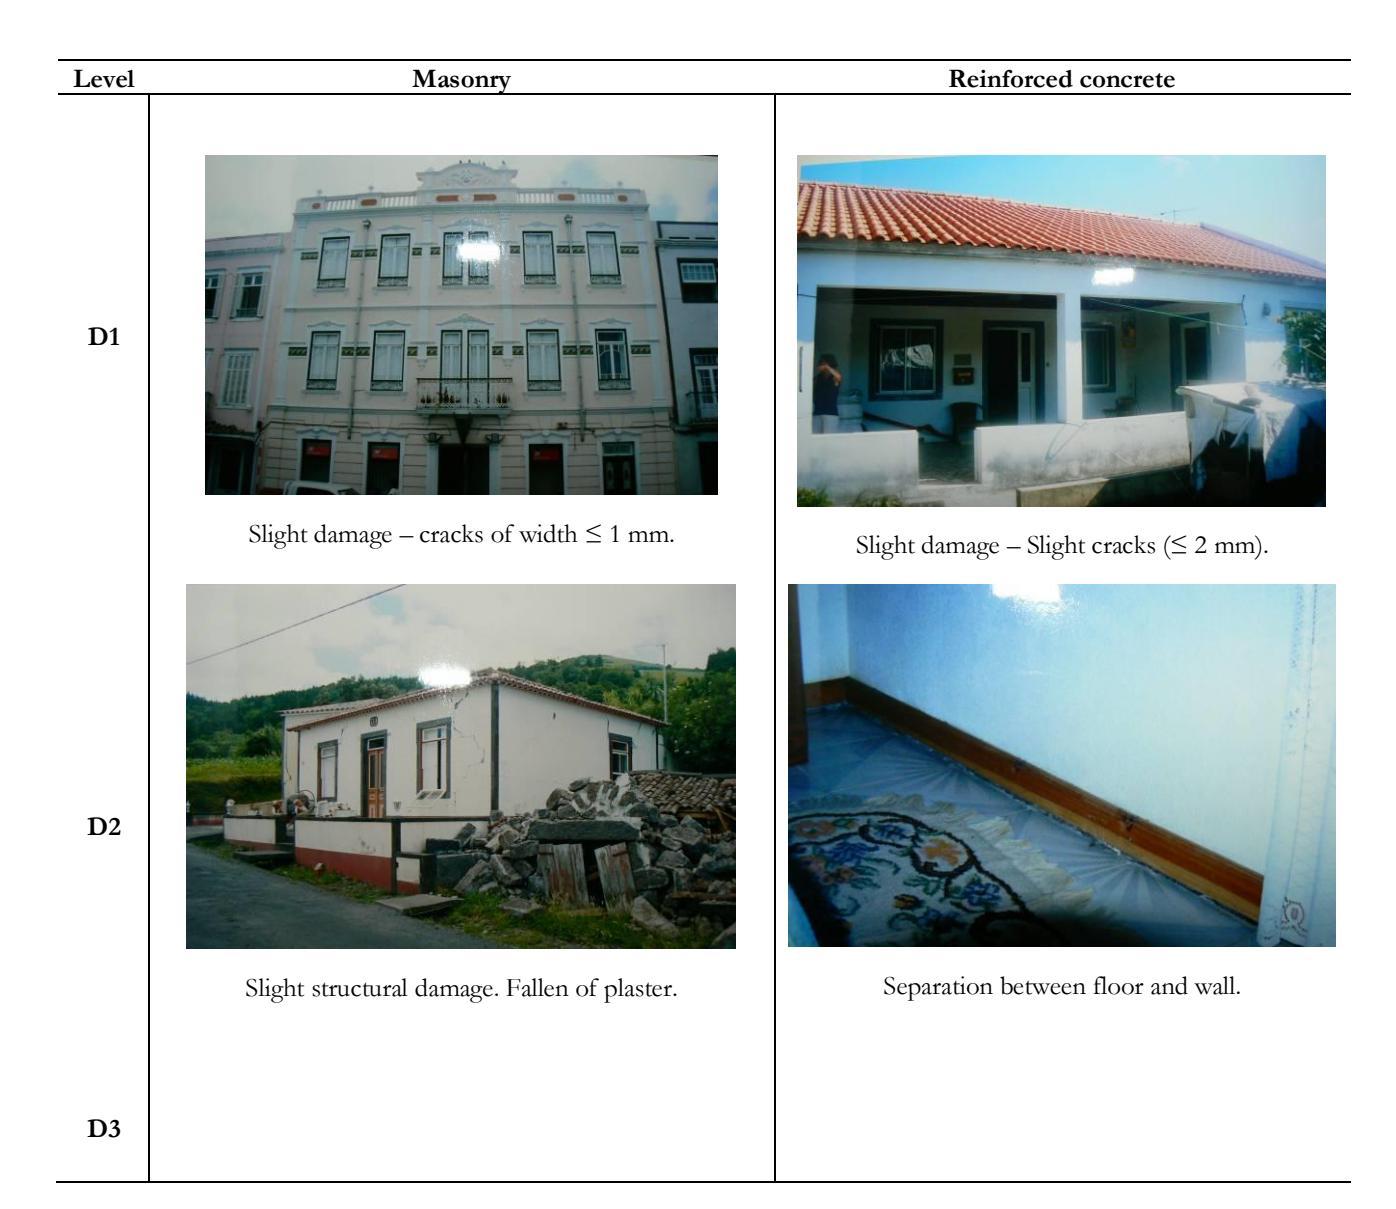
## Table 18 – Examples of damage grade classification to masonry and reinforced concrete buildings - Azores

Falling of tiles. Large and extensive cracks in the exterior walls.

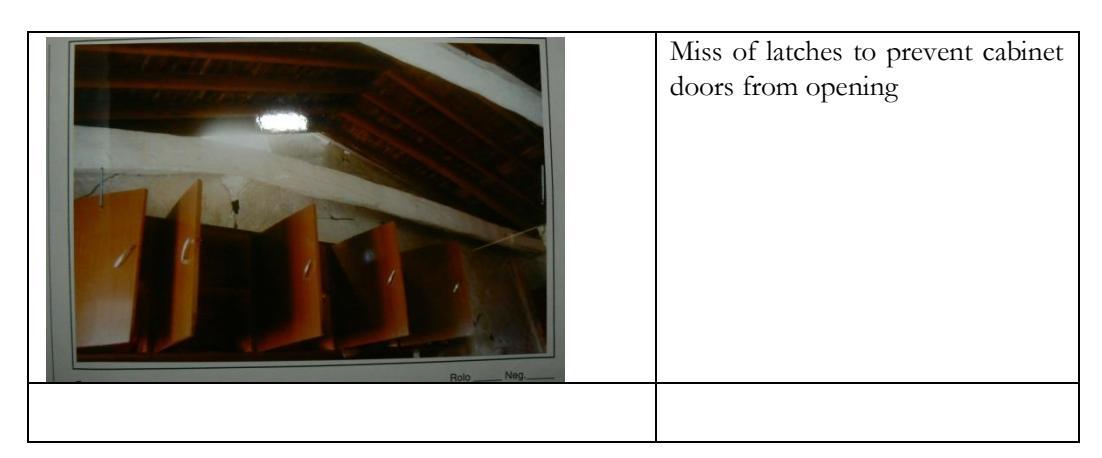
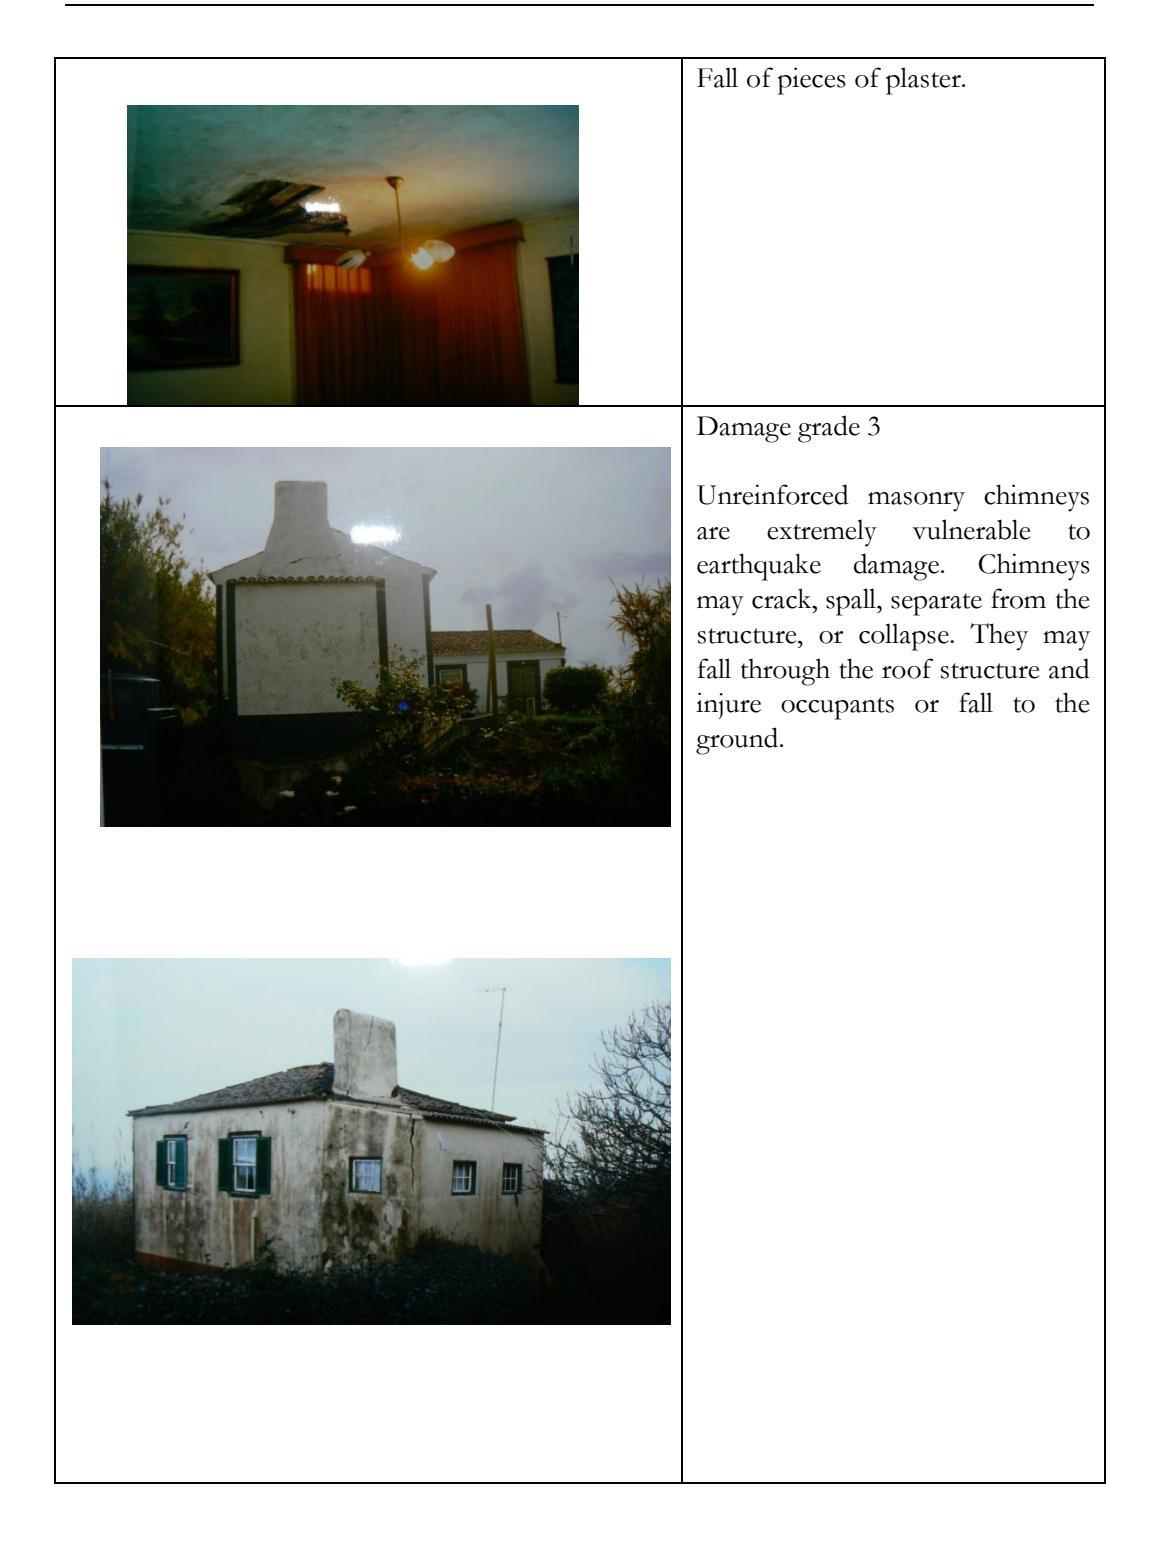
Table 19 – Typical damage to non-structural components - Azores

damage to exterior walls around windows
Non anchored masonry veneer Falling masonry walls may injure people and block pedestrian walkways, driveways, streets and access for emergency vehicles during an emergency.
