Know your city, Reduce seISmic risK through non-structural elements

## Post-Earthquake Reconnaissance Report Amatrice and Norcia, Italy

October 2016

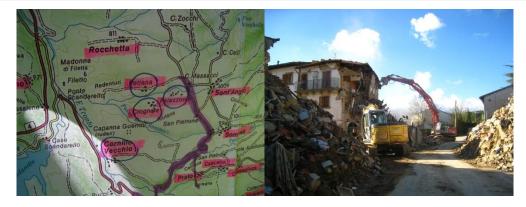
**27<sup>th</sup> October** – Due to the earthquakes of the previous day (M 5.4 and M 5.9), the fireman that should have led the visit to Amatrice became unavailable and we could not enter in the "red zone". Therefore this day was spent by both teams in the small villages around Amatrice (Petrana, Cornillo Vecchio, etc.) that were also strongly damaged during the 24<sup>th</sup> August earthquake. It is thought that in terms of the scientific interest maybe it was equivalent, as those villages were also "empty" of people and badly damaged, eventually not as much as Amatrice itself. The observed damages were registered in hundreds of photos.

Left: Some localities visited by the KnowRISK Team. Right: Building demolition and debris removal
